# Rehabilitation of Wastewater Collection and Water Distribution Systems

EPA/600/R-09/048

**State of Technology Review Report  
on  
Rehabilitation of Wastewater Collection  
and Water Distribution Systems**

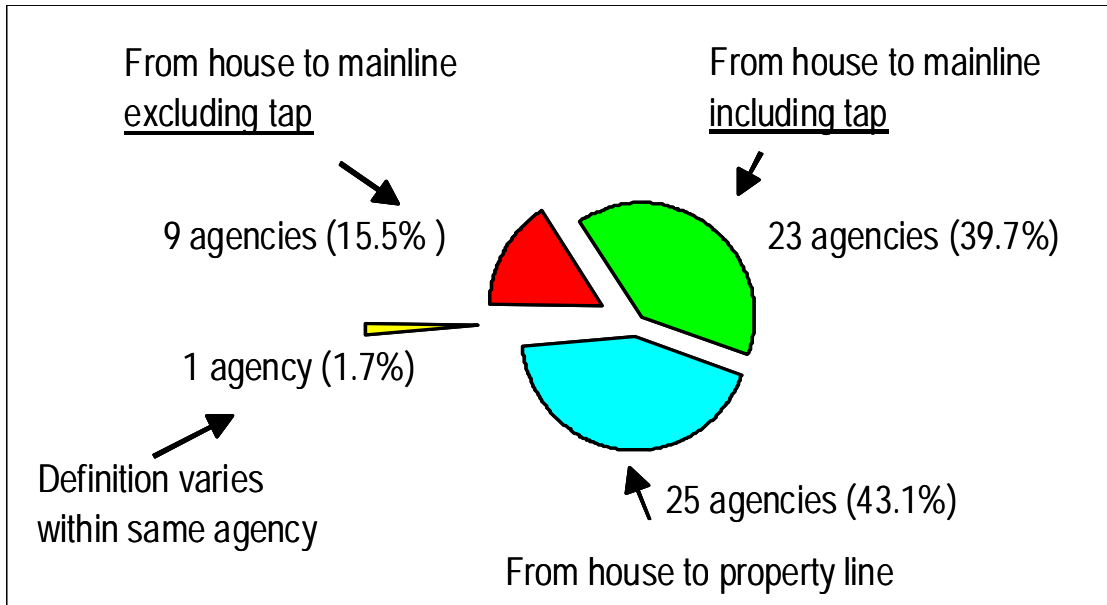
**Figure 1. Private Ownership of Sewer Laterals (WERF, 2006)**

Ownership of sewer laterals varies significantly for municipalities even within a single metropolitan area. As shown in Figure 1 (WERF, 2006), most commonly, the private property owner owns the lateral sewer all the way to the sewer main in the street (55.2 percent in the referenced survey), but there is a split as to who owns the actual connection into the main (often called a sewer “tap”). A smaller percentage (43.1 percent) of property owners owns the lateral only to the property line. There is also a significant difference of opinion as to whether cleanouts should be installed at the private property line. Where cleanouts are installed, these often serve as the demarcation of private and public ownership, but not in all cases. Cleanouts do help greatly with some types of rehabilitation, can assist in maintenance, and also make it easier to determine whether the private or the public section of a lateral is causing the I&I problem.

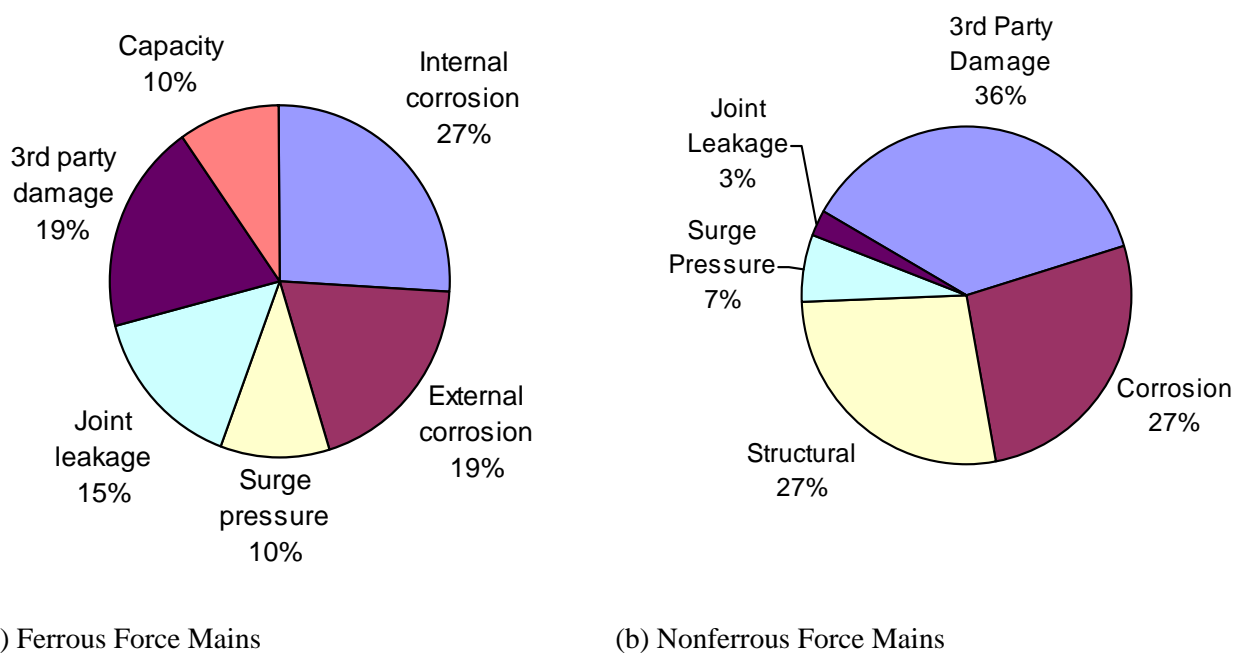
**Figure 2. Main Causes of Failure in Ferrous and Non-ferrous Force Mains**

**3.3.3 Force Mains.** Force mains that carry sewage flows under pressure represent a special set of challenges for sewer rehabilitation. As mentioned earlier, they represent approximately 7.5 percent of the system and typically use materials that are not used elsewhere in the sewer system such as steel, cast iron, and ductile iron. While siphons may be provided with redundancy for cleaning and inspection, most force mains do not have a bypass flow line and hence are difficult to take out of service for inspection or rehabilitation. The combination of corrosion potential, lack of inspection, and severe consequences for a failure make force mains a particular issue of concern. Figure 2 indicates the main causes of failure in ferrous and non-ferrous force mains.

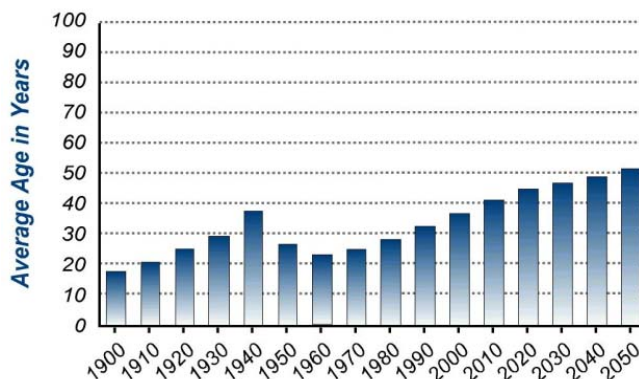
**Figure 3. Historical and Projected Average Age of U.S. Water System (EPA, 2002)**

significant action is quickly taken, the problem will only worsen as the average pipe age continues to increase without significant replacement or renewal. As shown in Figure 3, the average pipe age in 2008 is about 38 years old, but by the year 2050 the average pipe age will be 50 years old. This is because of the boom in water pipeline installations that took place after WWII. From 1870 to 1945 less than 20,000 miles of pipe were installed each decade. However, after 1945 this rate increased to over 80,000 miles of pipe. The commonly accepted design life for a water distribution or transmission main was approximately 50 years. Many pipes, especially older cast iron water mains, which had very thick pipe walls compared to today’s AWWA standards requirements, have had useful service lives in excess of 100 years. However, minimum wall thickness requirements for ductile iron pipes have dropped over the years due to competitive pressure from thermoplastic materials, resulting in an increased frequency of failures in ferrous pipes. The design basis for thermoplastic and glass-reinforced thermoset pipes is predicated upon applying a suitable factor of safety to the pipe material’s predicted tensile strength under a constant load in 11.4 or 50 years, respectively. Many of the ferrous and polymer-based water pipes will provide adequate service for at least 50 years, especially at reduced service pressures, but the frequency of failures will start to increase. For corrosion related failures, the rate of increase can be exponential. Depending on the service conditions, some pipes can be considered “middle-aged” at 50 years, while others must be considered “old” or near the end of their life cycle.
